**Second  
International Conference  
on  
Case Histories in  
Geotechnical Engineering**

**June 1-5, 1988**

**University of Missouri-Rolla  
Rolla, Missouri**

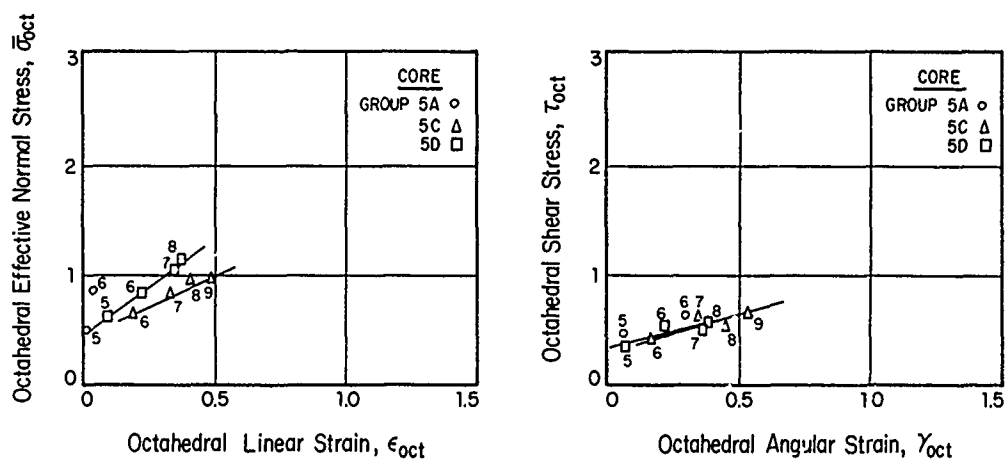
Fig. 11 Octahedral stress-strain curves for clusters No. 5 (Core)

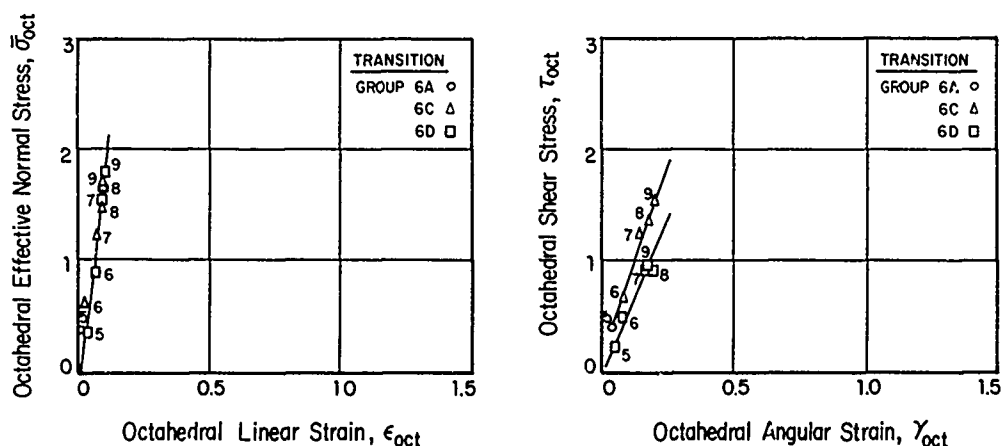
Fig. 12 Octahedral stress-strain curves for clusters No. 6 (Transition)

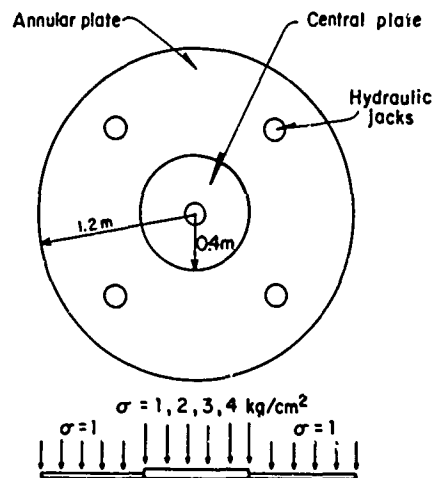
Fig. 13 Schematic layout of a CPBT

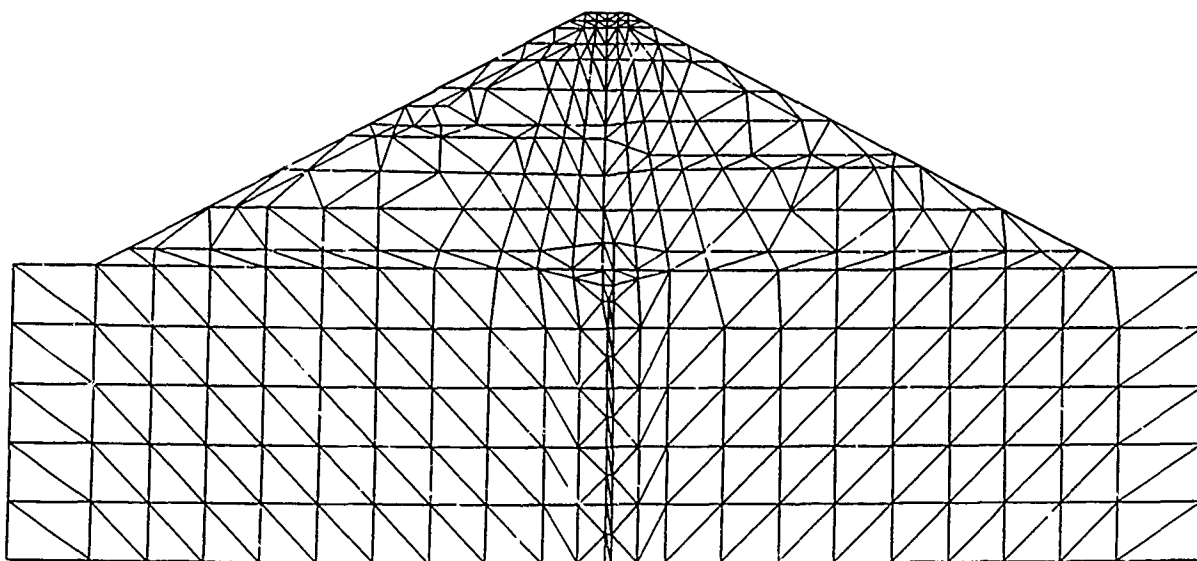
Fig. 15 Finite element mesh

by the Finite Element Method (FEM) was made taking into consideration a plane strain state in the maximum cross-section of the dam. The mesh used is shown in fig 15; the triangular elements are of such a kind that the strain is constant all through each element. To take account of the incremental construction, the FEM idealization was arranged in ten horizontal layers corresponding to construction lifts; the results presented below are the ones corresponding to the end of the construction.

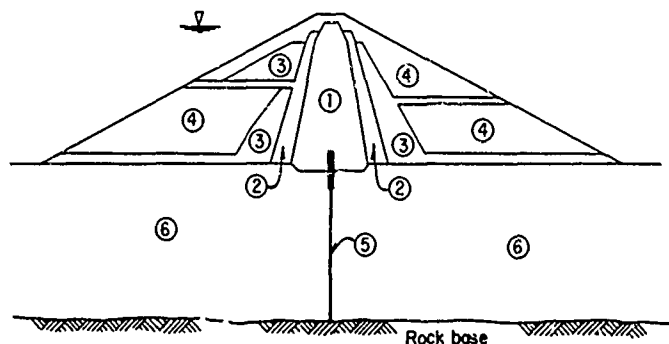
Fig. 16 Materials used in the FEM analysis

Fig 16 shows the distribution of materials which were used for the numerical analysis. Note that the materials 4, 5, 6, F1 and F2 were assigned the properties of material 4. Besides, since no CPBT were made in the brown plastic clay and there is no instrumental information about this material, it was considered that the whole core is formed by the silty red clay (material 1).

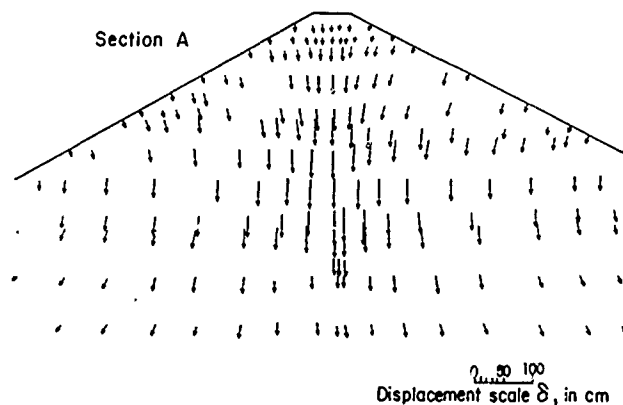
Fig. 17 Computed displacements at the end of construction

The resulting displacement vectors and vertical stress configuration are presented in figs 17 and 18, respectively. Note the tendency of the dam material to move towards its interior whereas the foundation material tends outwards, fig 17. In fig 18, three vertical stress concentrations stand out, one in the core above the cut-off wall and two others also in the clay near the filters, because of the interaction between the compressible core and the rigid diaphragm wall and the rigid filters.

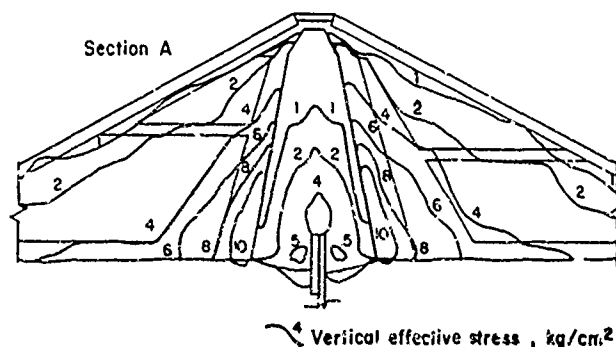
Fig. 18 Contours of equal vertical effective stresses

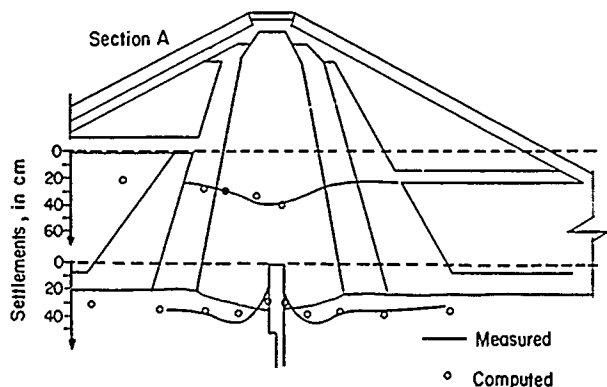
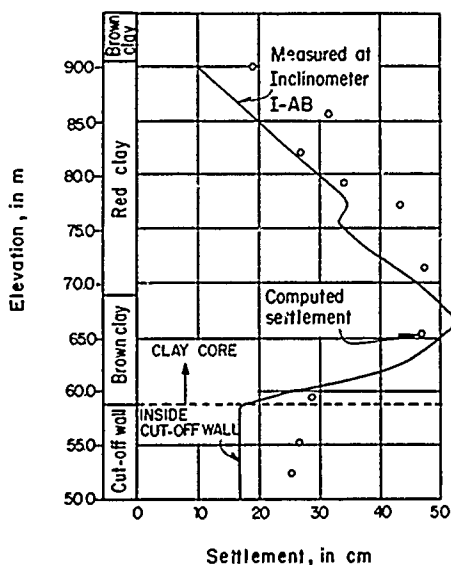
Fig. 20 Measured vs computed settlements

In regard to the measured and calculated settlements, these are compared in fig 20, where the settlements measured with the central inclinometer I-AB and the settlements measured at elev 59 (crest of the cut-off wall) and elev 77 are shown. In this figure once again the

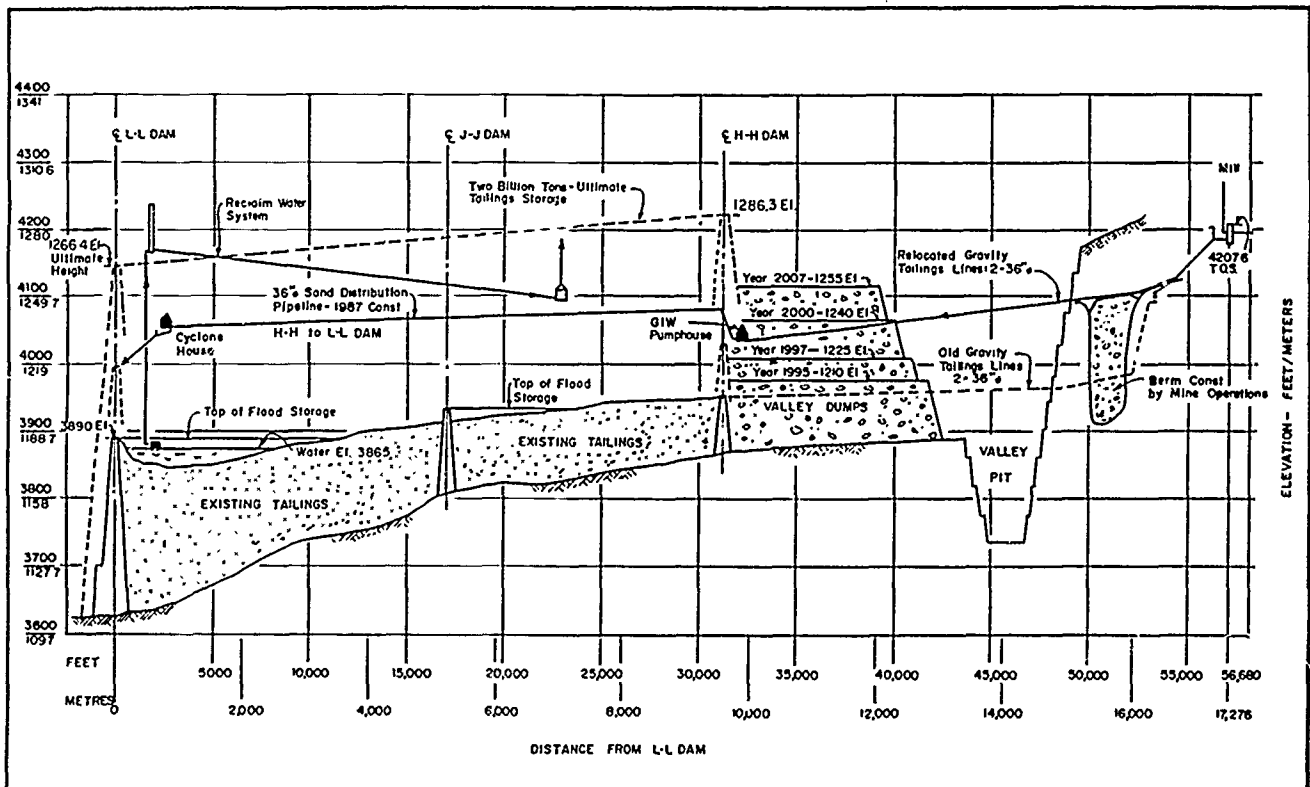
Fig. 3. Section Through Highland Valley Tailings Facility

named after the alignment alternatives in the initial feasibility studies. A section through the Highland Valley from the Lornex mill to the L-L Dam is shown in Fig. 3. From 1970 to 1977 Canadian Bechtel Ltd. advised Lornex on tailings storage at the H-H and J-J Dams and the L-L Starter Dam. Since the completion of the L-L Starter Dam in 1977, Klohn Leonoff Ltd.

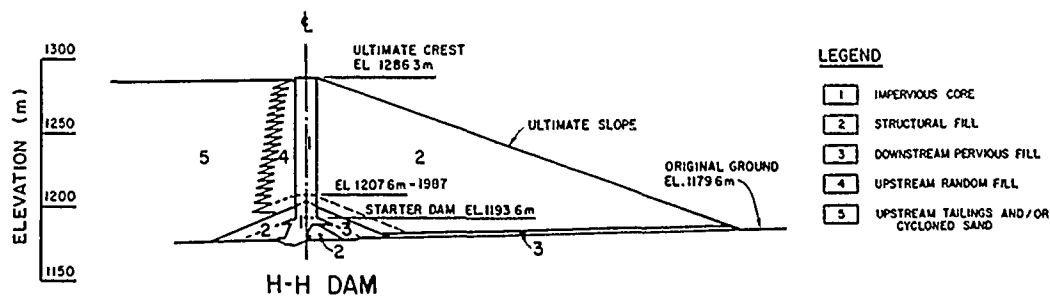
Fig. 5. Typical H-H Dam Section

The Starter Dam, the impervious glacial till core and the downstream shell materials are compacted to a minimum of 97% standard Proctor density. Upstream of the central core, the random fill is lightly compacted by routing construction equipment over the area during fill placement.

The future raising of the H-H Dam will continue the current practice of using natural borrow material for the central core and downstream zones. However, the relative cost of using cycloned sand and/or stripped overburden materials from the Valley Pit as fill materials for the downstream zone will be investigated to check their economic viability. Table 1 indicates required embankment volumes for the H-H Dam per unit of tailings storage. The ratio of embankment volume to tailings storage is quite small, in the range of 3 to 5 m<sup>3</sup>/1000 m<sup>3</sup> after 1988. Because of this low ratio, it is not justified to install a very sophisticated cyclone sand facility at the H-H Dam. Moreover, as the western limit of Valley Pit waste dumps progresses towards the H-H Dam, the incremental cost of hauling pit overburden from the waste dumps to the dam will decrease. Thus, the source of downstream fill for the H-H Dam may shift from natural borrow materials to mine waste. After 1995 the waste dumps will abut against the H-H Dam and act as an enormous downstream buttress.

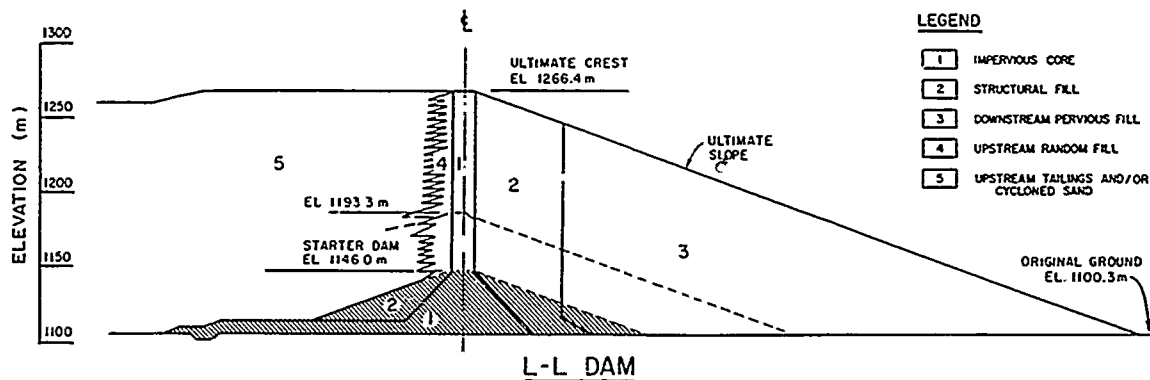
Fig. 6. Typical L-L Dam section

- (1) excavating the soft swamp and lacustrine deposits from beneath downstream construction stages of the dam and replacing them with compacted granular fill, and
- (2) constructing a large buttress berm downstream of that portion of the Starter Dam founded on the soft deposits (Klohn, Lo and Olsen 1982).

Upon completion of the Starter Dam, a large portion of the tailings pumped to the L-L Dam was used to fill the void at the bottom of the valley immediately upstream of the dam. The filling involved on-dam cycloning, uniform spigotting, and end discharge from large pipes. From 1978 to 1979 all fill placed in the downstream zone of the dam came from natural borrow. Since 1980, the amount of cycloned sand used in the downstream zone has been steadily increased. By 1982, downstream fill came almost exclusively from cycloned sand. Cost-effective and efficient construction techniques involving direct hydraulic placement and mechanical compaction by bulldozers for handling and placing the sand have been developed since 1982 (Scott and Lo 1984). Table 2 shows required embankment volumes for the L-L Dam per unit of tailings storage since 1976. The ratio of embankment volume to tailings storage is quite large, in the range of 20 to 37 m<sup>3</sup>/1000 m<sup>3</sup>. The ratio was even higher during the Starter Dam construction in 1976 to 1978, and again during accelerated construction in 1987 to make up flood storage lost with the burial of the J-J Dam. With the exception of above two periods, the ratio steadily drops from 37 in 1979 to 20 in 1992. Therefore, the cycloned sand delivery system designed for earlier years will develop excess capacity in later years. With greater volumes of cycloned sand available for dam construction in the future, techniques with potential to further reduce construction cost will be studied.

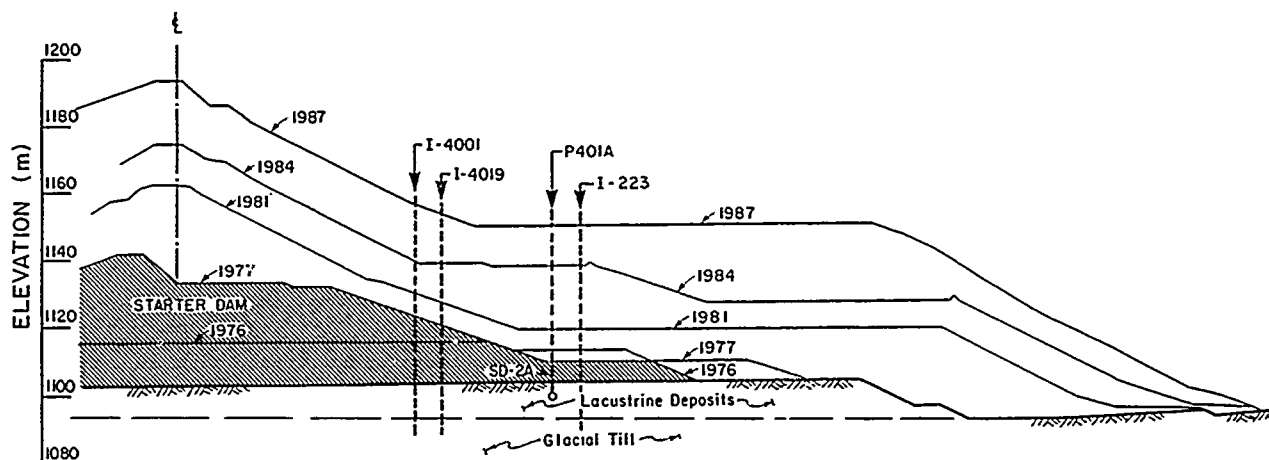
Fig. 7. L-L Dam Valley Section Over Lacustrine Deposits

upstream cutoff trench, constructed with locally borrowed soil over the soft swamp and lacustrine deposits (see Figs. 6 and 7). A system of vertical geo-drains and a horizontal sand and gravel blanket were used to accelerate the consolidation rate of the lacustrine deposits. The construction of the Starter Dam was also staged over two years: a 12.2 m high fill placed in 1976; and 30.5 m of fill placed in 1977. In addition, the foundation of the Starter Dam was extensively instrumented. Salient features of the design and construction of the Starter Dam were summarized by Burke and Smucha (1979).

Comprehensive instrumentation installed for monitoring the foundation performance of the Starter Dam consists of shallow pneumatic and standpipe (Geonor and Casagrande) piezometers, deep standpipe piezometers and observation wells, inclinometers, and pneumatic settlement gauges. Figure 7 shows the location of some instrumentation to be discussed later. This instrumentation has been maintained and expanded to include standpipe piezometers monitoring the saturation level in the dam fill. Piezometers located in the downstream pervious fills continue to show low saturation levels. Readings from shallow foundation piezometers located in the lacustrine deposits reflect the usual pattern of pore pressure rise during fill placement and its gradual dissipation with time. Shallow foundation piezometers located in the glacial till beneath the Starter Dam and abutment sections show little influence of seepage from the tailings pond. Deep foundation piezometer and observation wells indicate little to minor change of groundwater regime at depth since water impoundment in the tailings pond in 1976. To date total foundation settlements for the Starter Dam range from 1 to 3 m. These settlements reflect the consolidation of the lacustrine deposits in response to the increasing embankment loading. Downstream horizontal foundation movements within the Starter Dam range from 100 mm to 500 mm. These movements reflect the ongoing foundation adjustments to the embankment loading under partially drained condition.

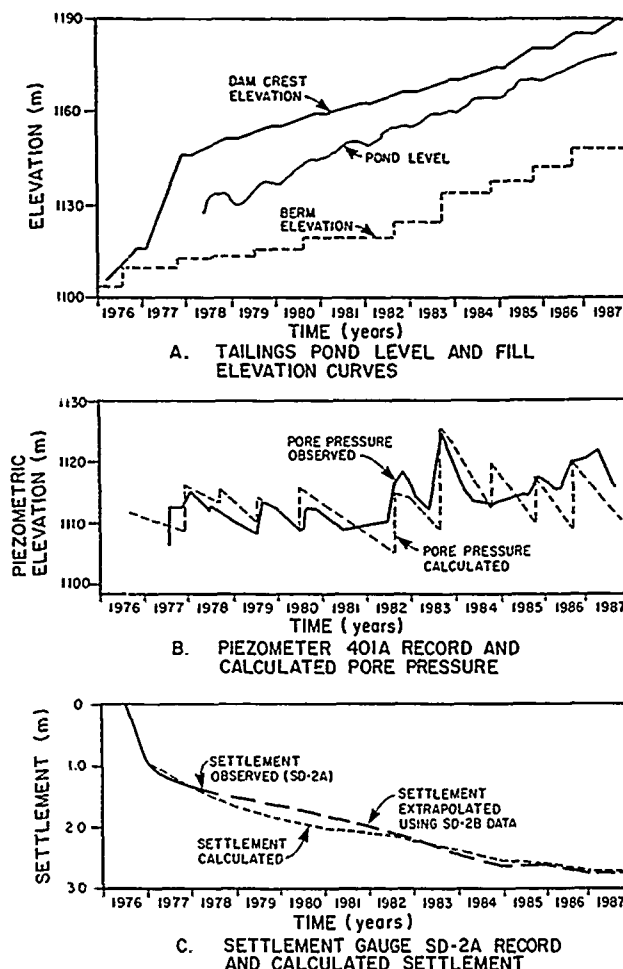
Fig. 8. Observed and Back Analyzed Pore Pressure and Settlement Data

Piezometric (P401A) and settlement (SD-2A) data from the lacustrine deposits beneath the Starter Dam are shown on Figs. 8(b) and (c). Solid lines represent continuous observation data, while long dashed lines represent extrapolated data based on other operating instruments. A one-dimensional consolidation finite-difference computer program (Wong and Duncan 1985) was used to back analyze the ongoing consolidation in response to fill loading in the berm area (see Fig. 8a). The computed pore pressure and settlement are also shown in Figs. 8(b) and 8(c) as short dashed lines. Table 3 summarizes laboratory test data and the back-analyzed field observation data. For the compression index,  $C_c$ , the field values are about one-half of the laboratory values possibly due to sample disturbance involved in laboratory tests. For the coefficient of consolidation,  $C_v$ , the field values are about four times the laboratory values. Horizontal stratification and the presence of vertical geo-drains in field deposits are considered as additional contributing factors to this difference between field and laboratory values.

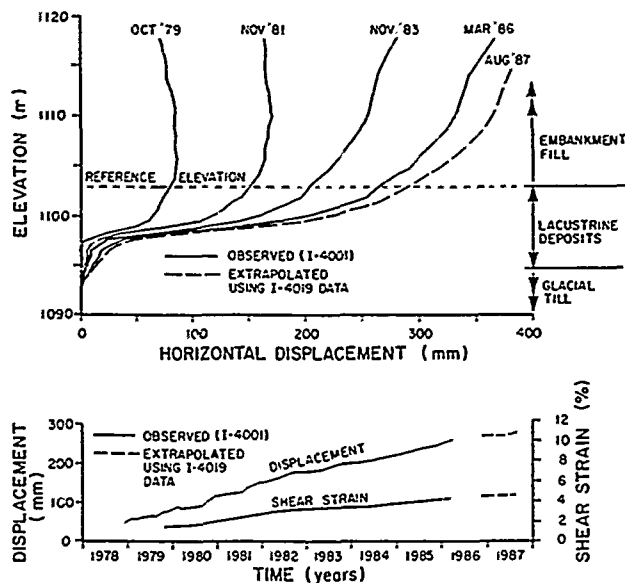
Fig. 9. Observed Inclinator Data

Inclinometer (I-223) data in the mid-valley section showed horizontal displacements of about 200 mm from 1976 to 1977. In 1978, Inclinometer I-4001 was installed as a replacement for I-223. The inclinometer data for I-4001 is shown in Fig. 9 as displacement profiles and accumulated displacement-time plots for a reference point at the foundation level. Solid lines represent continuous observation data, while dashed lines represent extrapolated data based on an adjacent inclinometer (I-4019) installed in 1986 as a replacement for I-4001. The majority of movement is confined to the upper silt-clay/varved clay horizons. Inferred average field shear strains based on the initial thickness of these horizons are also shown in Fig. 9. Using the decreased thickness obtained from recorded settlements, the shear strain would be about 30% larger than that shown in Fig. 9 at the end of 1987.

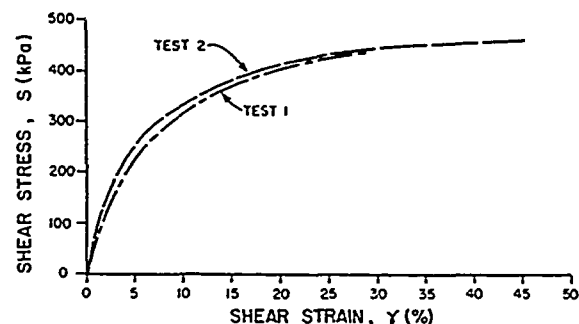
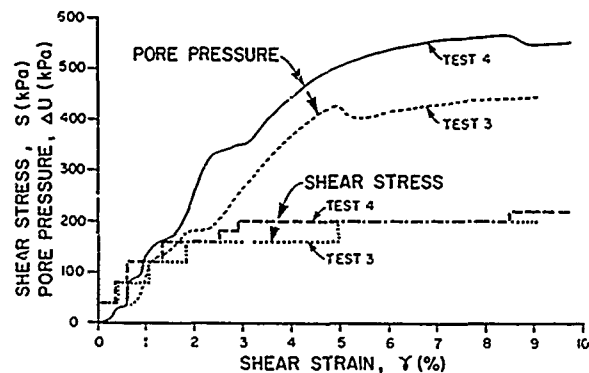
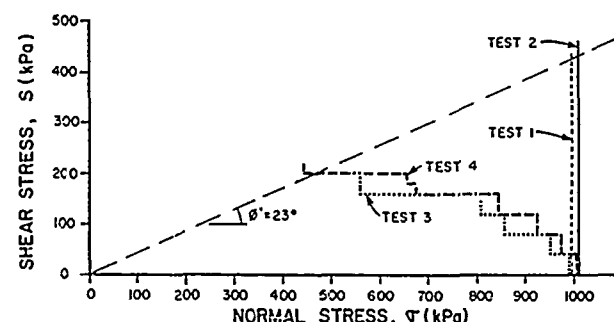
A. CONSOLIDATED-DRAINED TESTS

B. CONSOLIDATED-UNDRAINED (CONSTANT VOLUME) TESTS

C. EFFECTIVE STRESS PATHS ON HORIZONTAL PLANE

Fig. 10. Summary of Simple Shear Test Results

The embankment loading induced foundation deformation of relatively soft lacustrine deposits between more rigid foundation soils at depth and compacted fill above can be closely simulated by laboratory simple shear tests. Four simple shear tests: two consolidated-drained (Tests 1 and 2) and two consolidated-undrained (constant volume Tests 3 and 4) were carried out at the University of British Columbia. Results of these tests are shown in Fig. 10. Under drained condition, large shear strains (in the order of 25%) are associated with the ultimate shear strength whereas under undrained condition the corresponding strains are much smaller (in the order of 2%). The accumulated field shear strain in the region of shown inclinometers, including that inferred from Fig. 9 and that occurred earlier, is in the order of 8% representing foundation deformation under partially drained condition.

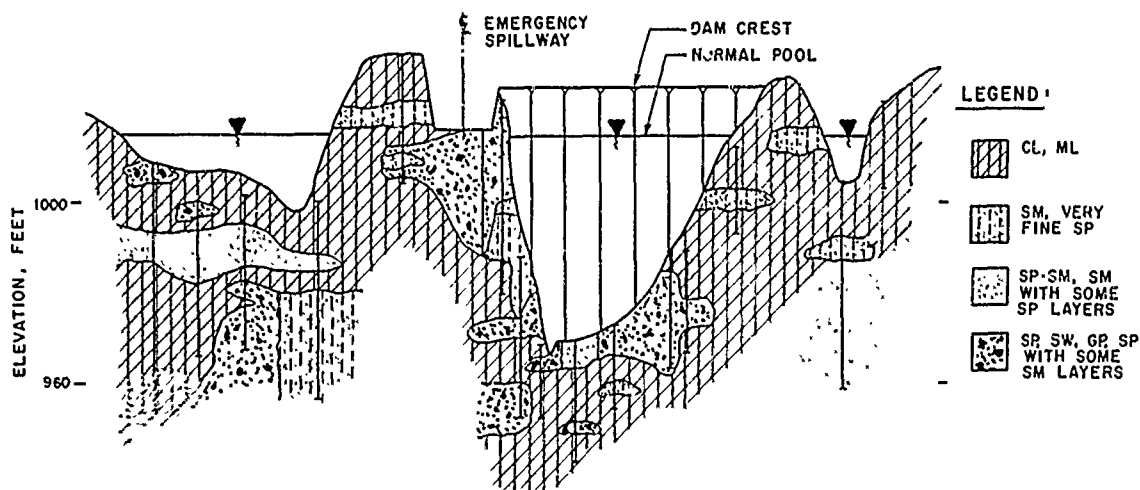
Figure 4. Subsurface Profile Beneath Dam (Section A-A', Figure 3)

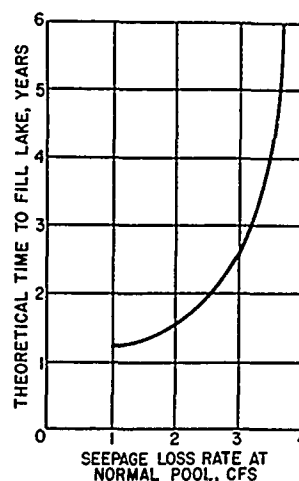
Figure 5. Theoretical Lake Filling Times

This TLS rate is consistent with Figure 5, in which the lake theoretically would not fill at a seepage loss rate of 4.0 cfs and the observation that the lake did not fill after the original construction (prior to the repair). To achieve a maximum normal pool TLS rate of 2.0 cfs (determined to be acceptable from Figure 5), it was decided to attempt to reduce the normal pool FES rate from 2.8 to 0.8 cfs, taken as a blanketing repair criterion.

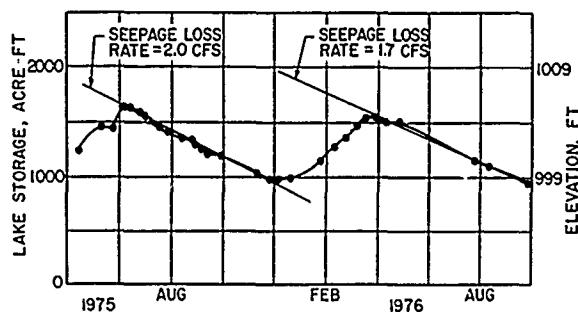
Figure 6. Total Lake Seepage (TLS) From Lake Elevation Records

From the records of lake elevation maintained after the original construction, it was possible to estimate total seepage loss rates based on the relationship between reservoir storage versus time, prior to repair, shown in Figure 6. The stream inflow was determined to be approximately equal to the evaporation loss rates during these periods.

table was developed by estimating a TLS rate of 2.0 cfs at lake Elevation 1002 from Figure 6 and a FES rate of 1.4 cfs from Figure 7. At lake Elevation 1015 (normal pool), the FES rate is 2.8 cfs, also from Figure 7. If it is assumed that the ratio between the FES and TLS rates remains constant with pool elevation, then the TLS rate would be about 4.0 cfs at the normal pool level.

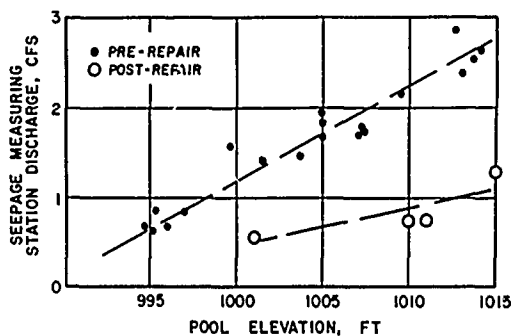
Figure 7. Measured Front End Seepage (FES), vs. Lake Elevation

Results of the observed flow at the downstream seepage measuring station are summarized in Figure 7. It can be seen that the pre-repair points (solid circles) essentially form a linear relationship with the lake elevation. The pre-repair data were also utilized to estimate the portion of the "total lake seepage" (TLS) that exited the lake through granular deposits in the foundation and abutments and was monitored downstream of the dam. This is hereafter referred to as "front end seepage" (FES). At the normal pool Elevation 1015, an FES seepage rate of 2.8 cfs was measured. A limited number of post-repair data points also are shown in Figure 7 as open circles.

During refilling, the seepage flow re-emerged, at a low rate, at Seep B. The available post-repair seepage flow measurements as shown in Figure 7 indicate that the FES level was reduced from its original normal pool rate of 2.8 to 1.2 cfs, but not to the intended design level of 0.8 cfs.

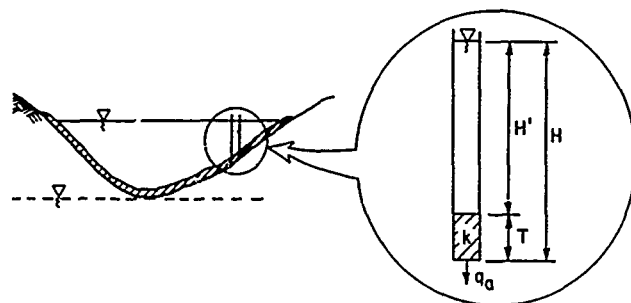
Figure 8. Idealized Seepage Model for Blanket

- T = required blanket thickness
- k = coefficient of permeability for blanket
- H' = height of water over blanket
- $q_a$  = allowable leakage per unit area

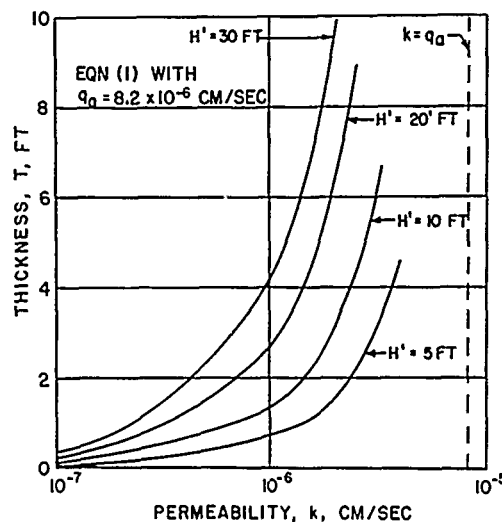
Figure 9. Blanket Thickness vs. Permeability

The value for  $q_a$  was determined by dividing the allowable normal pool FES seepage criterion of 0.8 cfs, as established in the preceding section, by the estimated contributory area to the FES. Design relationships between the parameters in this equation are shown in Figure 9 illustrating the sensitivity to the design k-value. It can be seen that if the field k-value is on the order of  $10^{-7}$  cm/sec, then the blanket thicknesses based on  $k = 1 \times 10^{-6}$  cm/sec are very conservative. On the other hand, if k

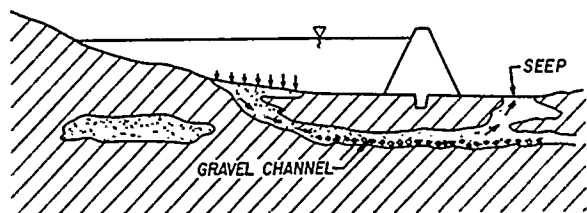
Figure 11. Possible Seepage Flow Path

upstream of the dam, suggested by the downstream location of Seep A and as depicted in Figure 11, led to the decision to extend the blanketing to a point about midway in the lake, as shown in Figure 10. This also provided a margin of safety considered appropriate in light of the very approximate nature of the above analyses.

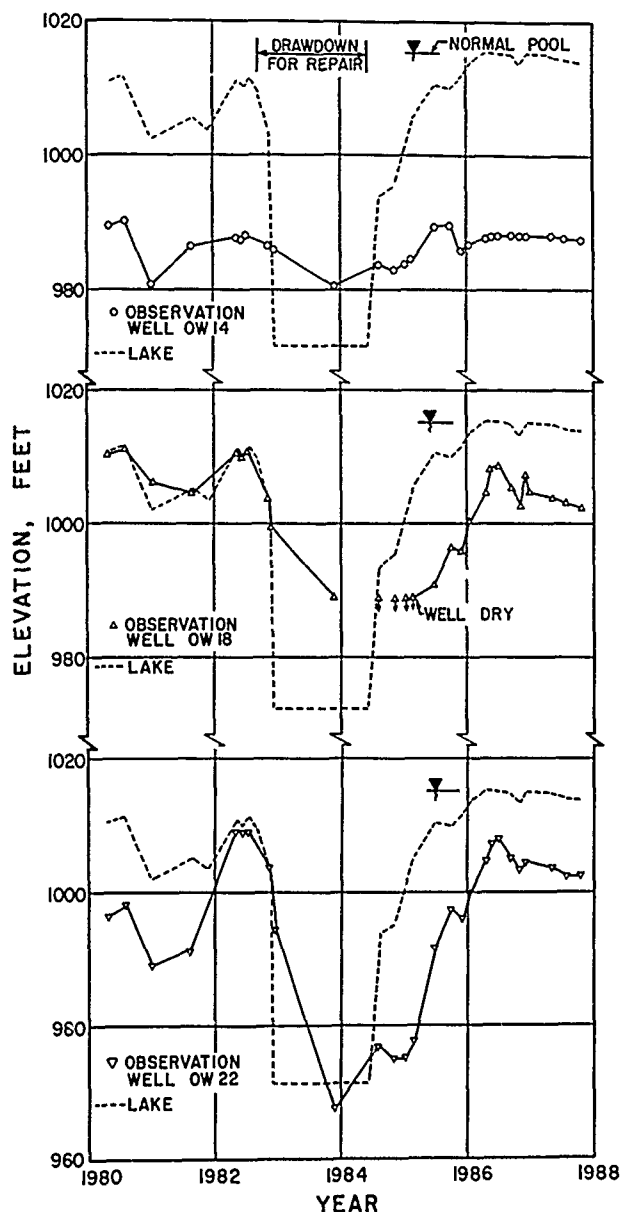
Figure 12. Measured Pre- and Post-Repair Groundwater Levels in Three Observation Wells

In general, the observation well readings were erratic, as would be expected for these conditions. However, some insight to the blanket performance is indicated by the readings in three typical groundwater observation wells, OW-14, OW-18, and OW-22, judged to be responsive to the lake levels before and after the blanketing repair, at locations shown in Figure 10. These readings are plotted in Figure 12. The before and after readings for OW-14 and OW-18 indicate an increased head loss or degree of separation between the lake and groundwater after the repair. The same holds true for OW-22 for lake levels above Elevation 1000.

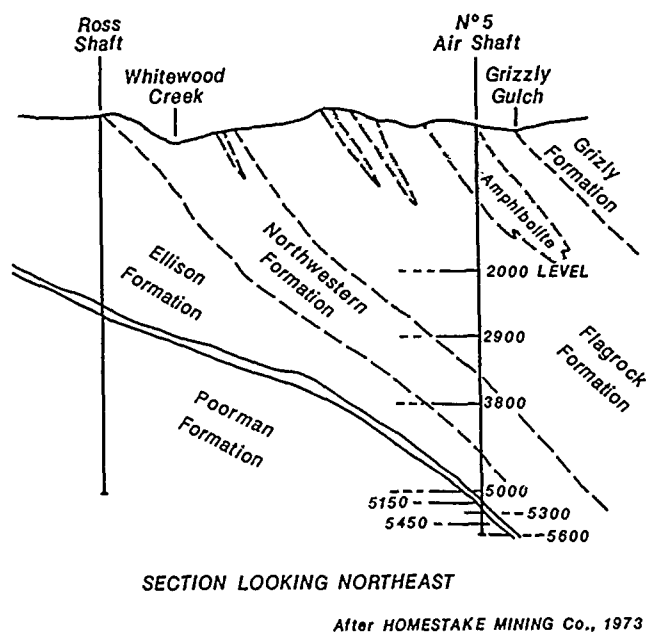
Figure 2 - Geologic Cross-Section of Grizzly Gulch

The three rock units in the vicinity of the dam site in ascending order are: Precambrian metamorphic units of the Grizzly and Flagrock Formations, Cambrian sedimentary beds of the Deadwood Formation, and Tertiary igneous dikes and sills. A geologic cross-section for the area is presented in Figure 2.

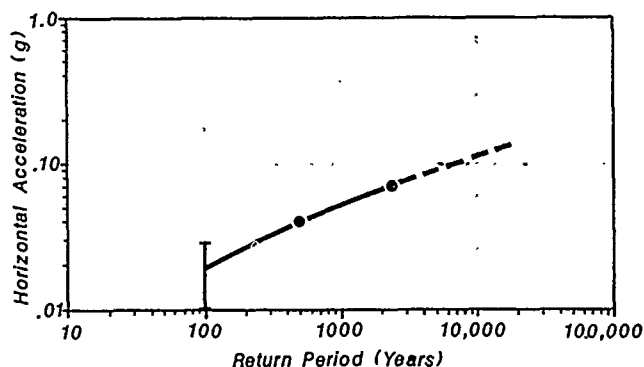
Figure 3 - Horizontal Acceleration vs. Return Period

Based on the work of Algermissen, probabilistic estimates of maximum horizontal acceleration in rock for exposure times of 10, 50 and 250 years at the 90% probability level of non-exceedence were established for the Grizzly Gulch site. The data is plotted in Figure 3, and it can be seen that for a return period of 10,000 years, an acceleration of 0.10 g is obtained. For a 250-year project life (return period greater than 2000 years), this corresponds to a 97.5% probability of non-exceedence and is a reasonable estimate of the maximum level of ground shaking to be expected within the bedrock surface at the dam site.

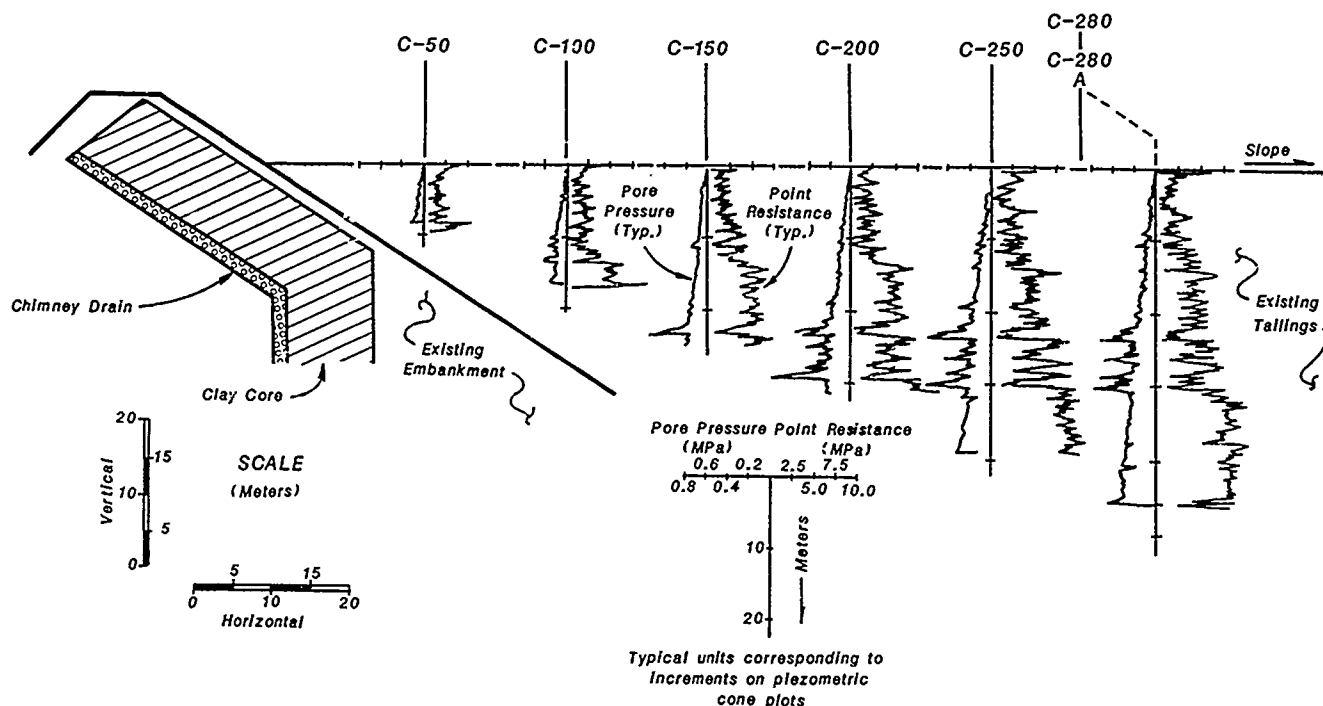
Figure 4 - Cross-Section of Tailings Deposit

The investigation involved an initial appraisal of the tailings deposit by use of a Fugro piezometric cone which provided detailed continuous site profiles, thus allowing critical zones to be identified. Tip resistance, sleeve friction and porewater pressure data were recorded every 2 cm and stored on a microcomputer disk. Visual display of all data was shown graphically on the computer screen during the test. Classification charts produced by Robertson and Campanella (1983) based on cone bearing and friction ratio, and by Jones and van Zyl (1981) based on cone bearing ratio and excess pore pressure were used to identify the coarser silty sands from the finer silts. In all cases, the excess pore pressures generated in the silts clearly identified these finer layers. A section line extending 185 m (600 ft.) onto the tailings is shown in Figure 4. It will be noticed that the material behaves as a typical hydraulically placed material with the coarser tailings (silty sands) generating high cone bearings and no excess pore pressures, while the finer tailings (silts) generally have low cone bearings and excess pore pressures. It will be seen from Figure 4 that the tailings mainly consist of coarser deposits with some minor layering of silts, and that the profile clearly shows the depositional history.

For example, the tailings deposited at 22 m (72 ft.) at 26 m (87 ft.) represent a rapid deposition period under water. Above 22 m (72 ft.) the depositional environment is relatively uniform, with the rapid variations in tip load reflecting the meandering of the outflow streams down the beach.

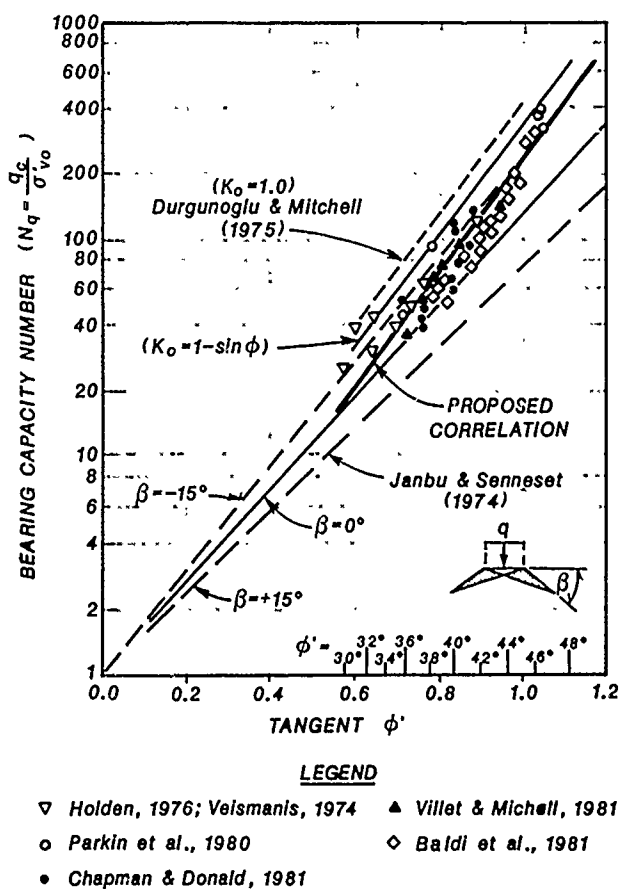
Figure 5 - Piezocone Correlation Chart

The drained shear strength parameters of cohesionless, normally consolidated, moderately incompressible quartz sands have been determined in calibration chamber studies. The proposed correlation of Robertson and Campanella (1983), Figure 5, has been used to determine the effective friction angle for the free draining deposit. A comparison of some of these results with laboratory and pressuremeter tests is provided in Table 1.

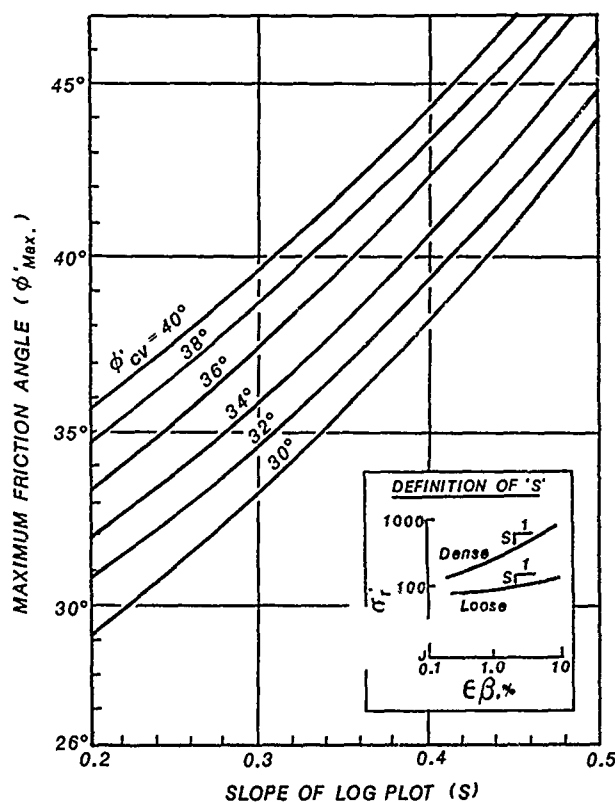
Figure 6 - Self-Boring Pressuremeter Calibration Graph

This method has been shown to be accurate for dense sands. For medium dense to loose sands, a correction which takes into account the dilation of the material is applied as shown in Figure 6. A summary of some of the comparative test results is shown in Table 1.

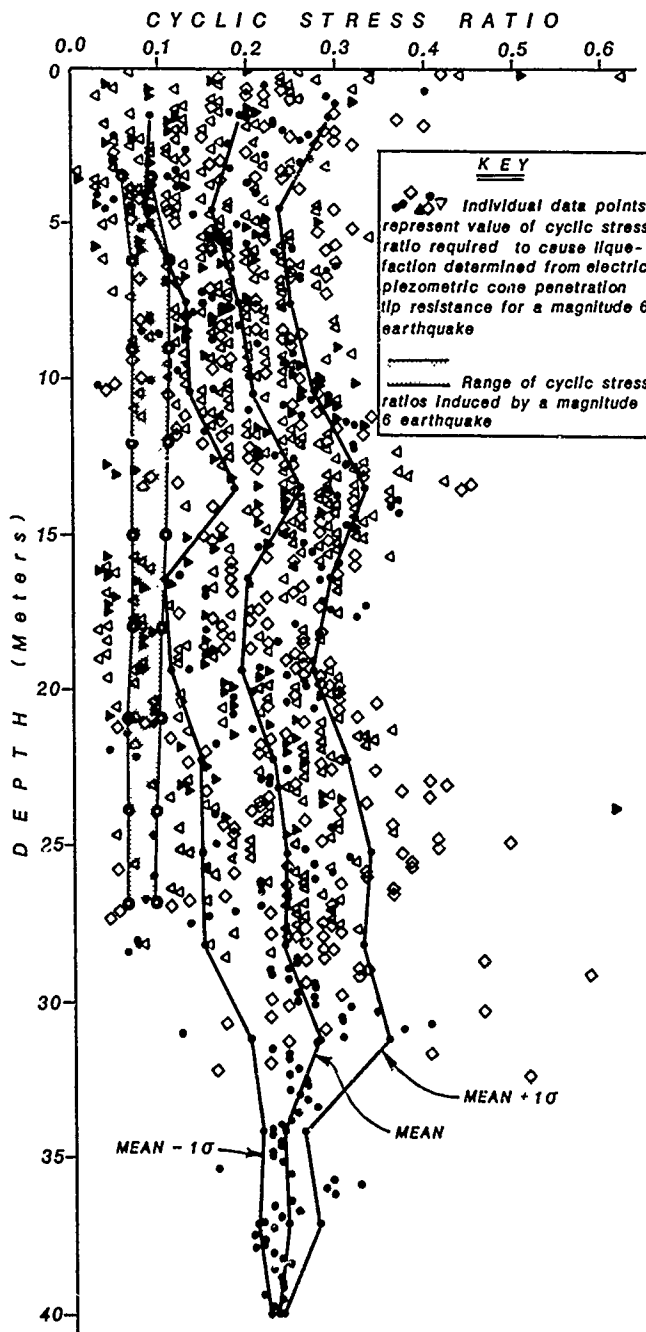
Figure 7 - CPT Cyclic Stress Ratios

ii) Corrected SPT (or CPT) data, along with empirical relationships (Seed et al, 1983, for SPT and Robertson and Campanella, 1983, 1984; Seed and De Alba, 1986, for CPT) used to estimate the cyclic stress ratios required to cause liquefaction with limited shear strain potential for the postulated maximum earthquake (Magnitude = 6).

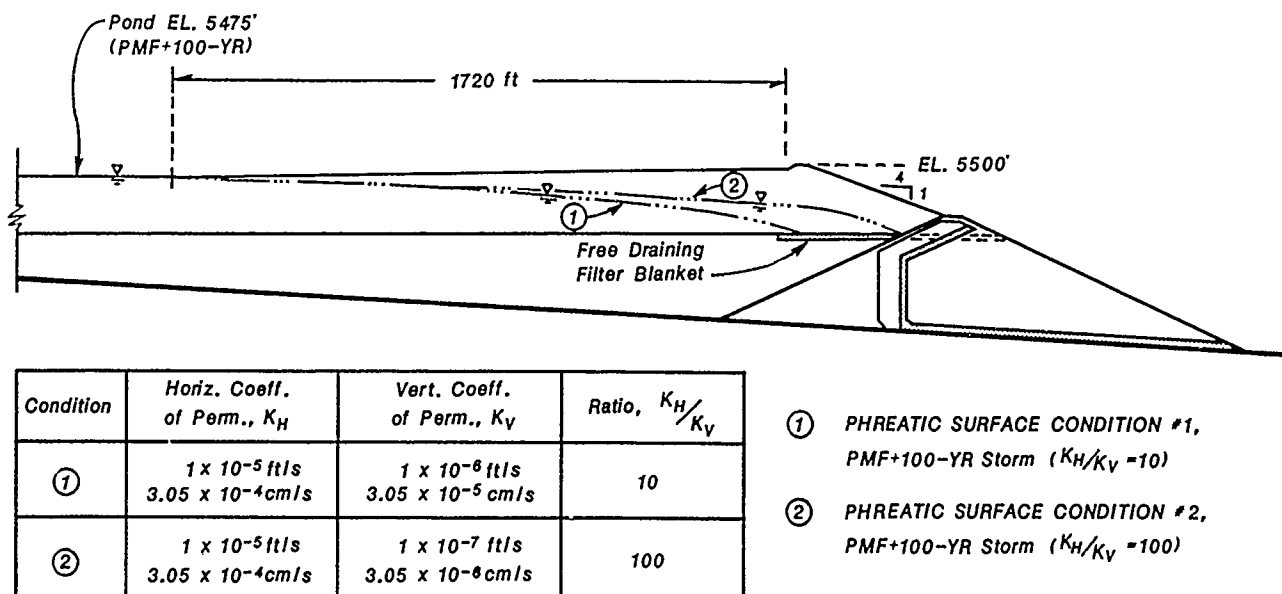
Figure 8 - Finite Element Determination of Phreatic Surface

A detailed water balance study was undertaken to determine the maximum elevation of the pond under the maximum design precipitation event, which for this study was the Possible Maximum Flood (PMF) plus 100-yr. storm effectively occurring back to back. The proposed sub-aerial deposition technique produces a highly anisotropic permeability condition as well as ensuring that the coarser sands are deposited close to the discharge on the embankment. The upstream design calls for an extensive horizontal drainage blanket to drain the sub-aerially deposited tailings beneath the embankment. A finite element seepage analysis for anisotropic tailings was carried out to determine the highest level of the phreatic surface under the maximum design precipitation. Figure 8 indicates a section through the tailings facility and the phreatic surfaces which were used for stability analysis.

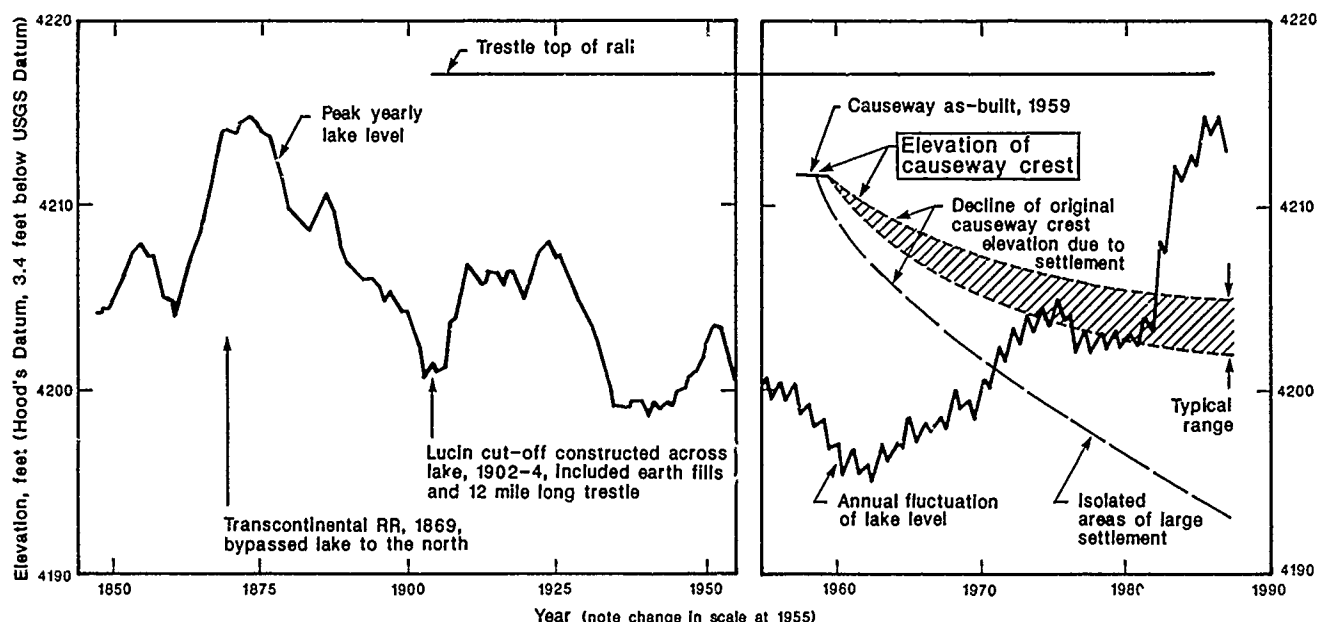
Figure 2. Levels of the Great Salt Lake and Causeway Crest.

However, the level of the Great Salt Lake, a lake with no natural outlet, has fluctuated nearly 20 ft. since 1959, see Figure 2. Recent historically high lake levels and continuing Causeway settlement due to foundation clay consolidation, also illustrated in Figure 2, have forced Southern

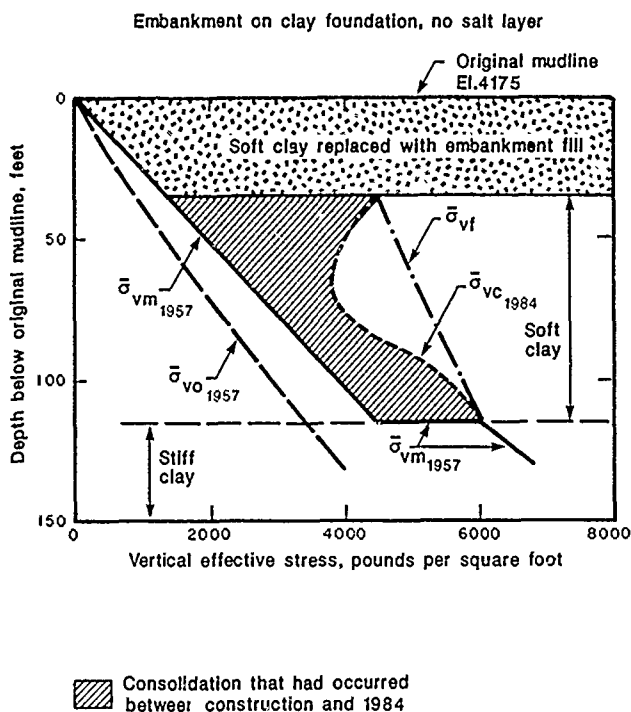
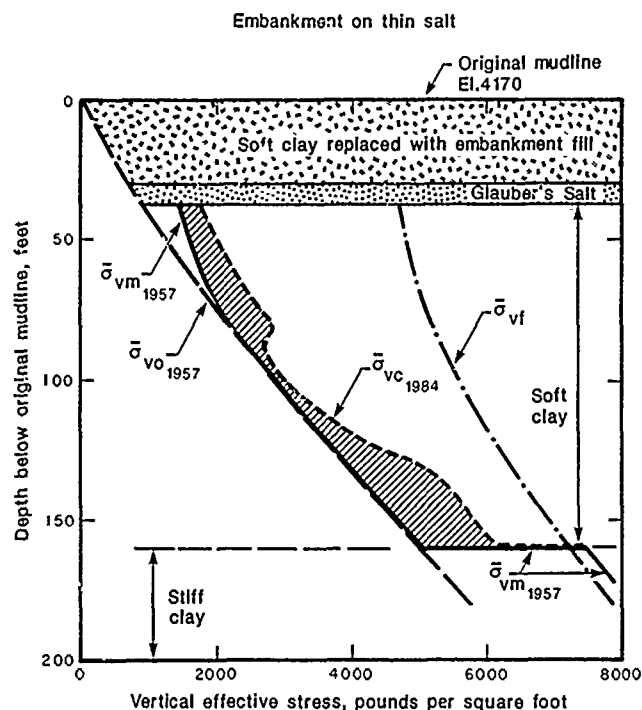
Figure 3. Stress Profiles Indicating Consolidation Since Causeway Construction.

The stress profiles shown in Figure 3 indicate that far less consolidation has occurred in clay overlain by the salt. This was an important discovery, because shear strength increase would be similarly less than where the salt is present. The Glauber's Salt stratum has apparently inhibited drainage from the underlying foundation clays. Thus less than 35 percent of the eventual consolidation has occurred in most salt areas.

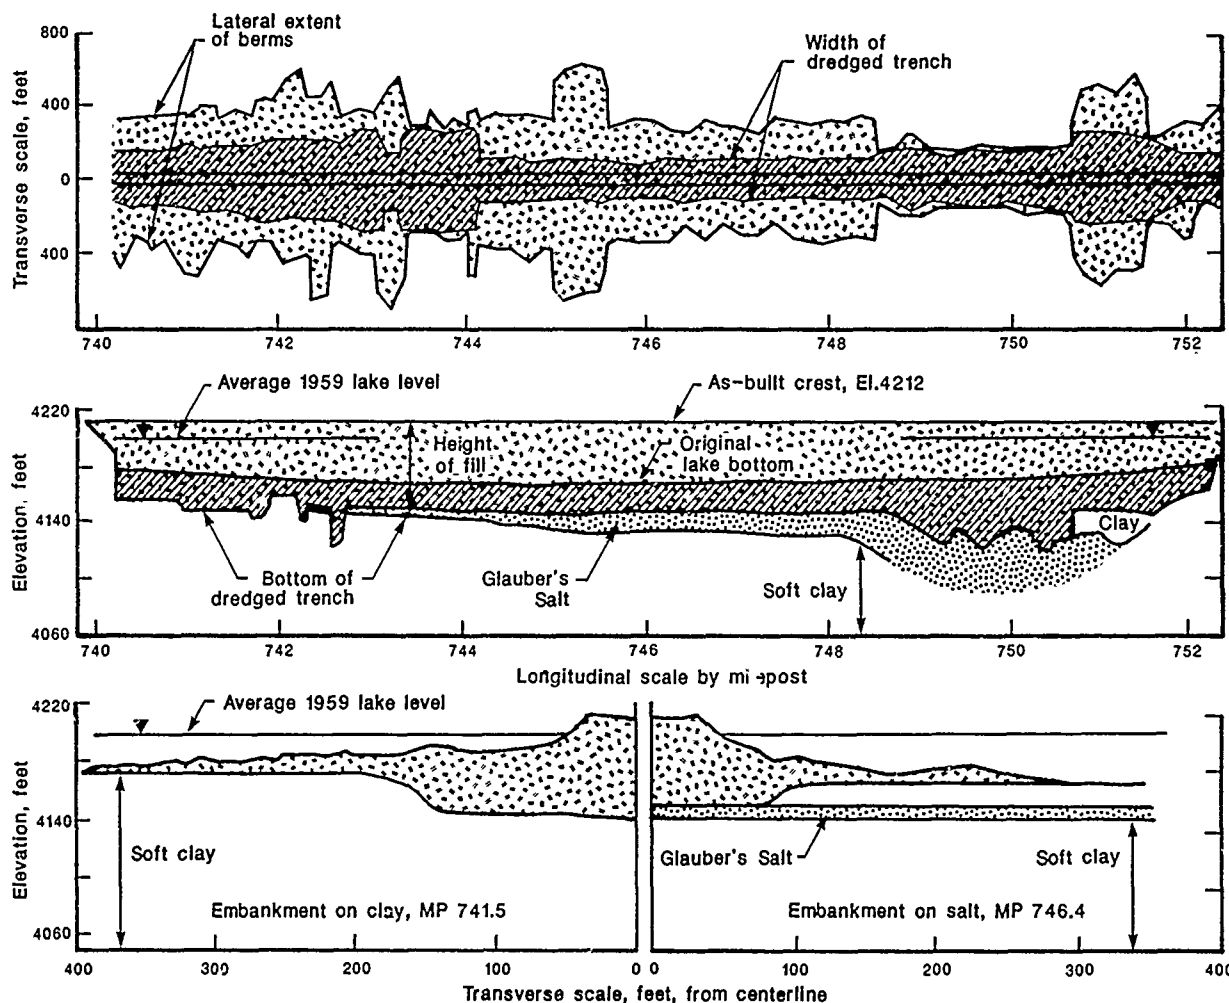
Figure 4. Plan, Profile, and Typical Cross-Sections of Causeway.

A plan of the completed Causeway circa 1959, a profile showing fill and salt thickness, and two typical cross-sections are shown in Figure 4.

Glauber's Salt. Counter-weight berms were placed adjacent to most sections of the main fill. The depth and width of the dredged trench, and berm width and locations are shown in Figure 4.
